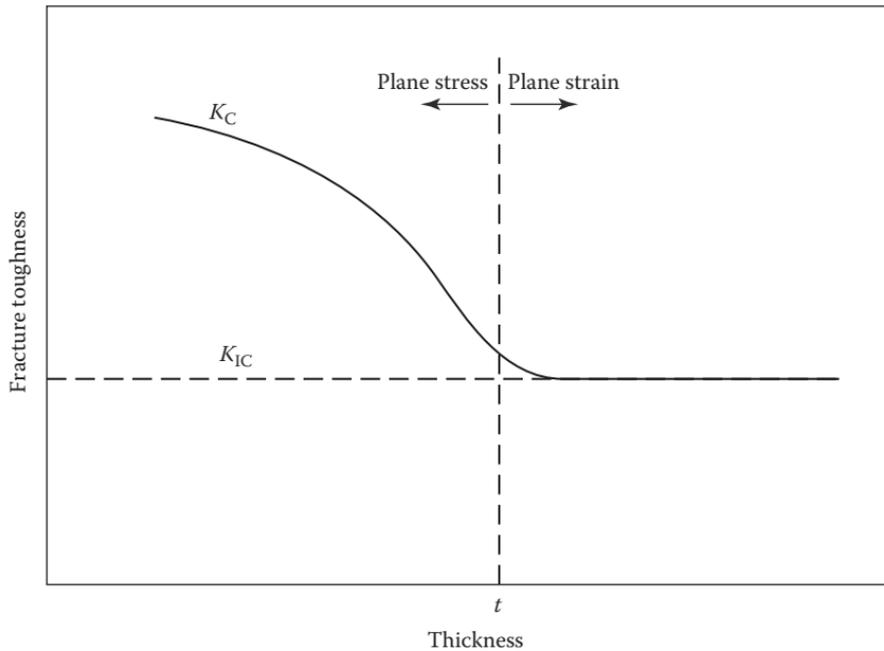
Figure 2.1 Effect of thickness on fracture toughness behavior.

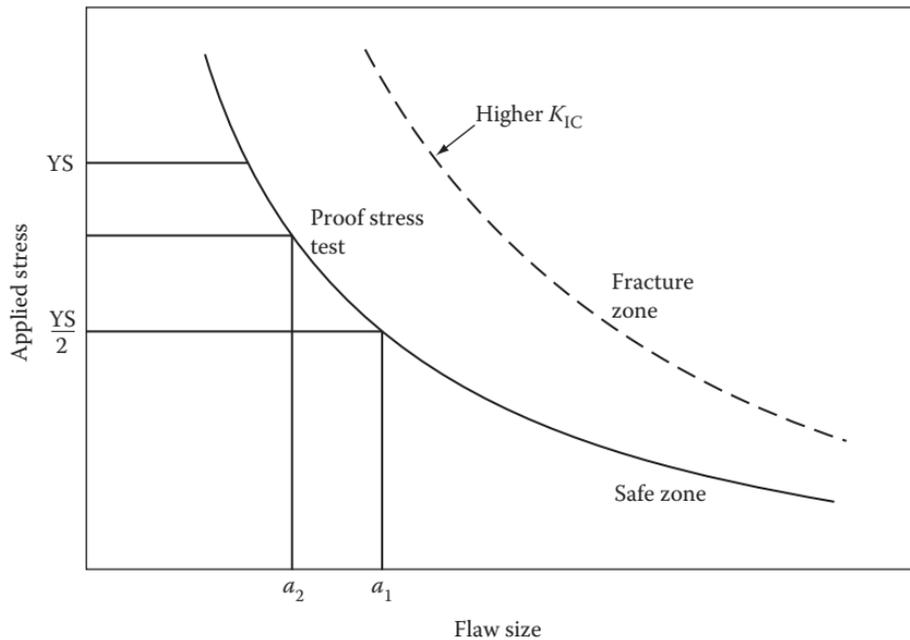
Figure 2.2 Schematic relationship between stress, flaw size, and fracture toughness.

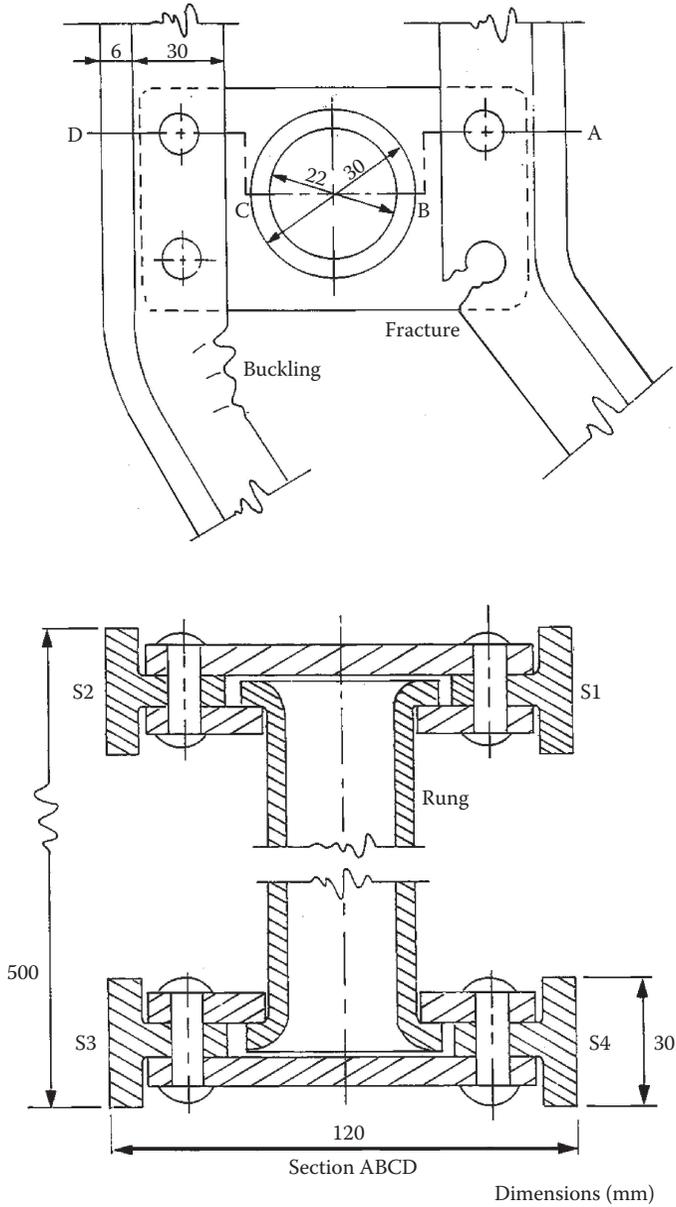
Figure 2.3 Failure of an aluminum ladder.

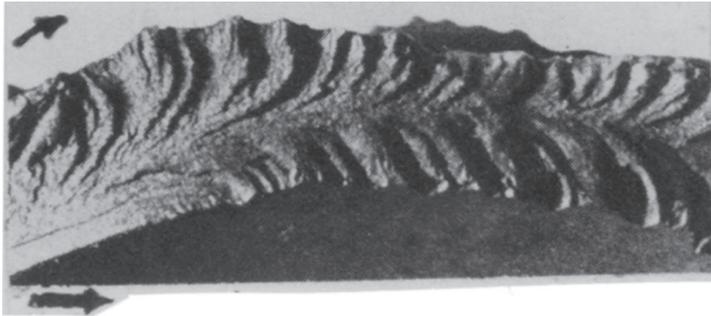
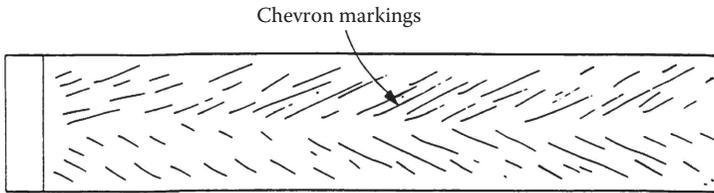
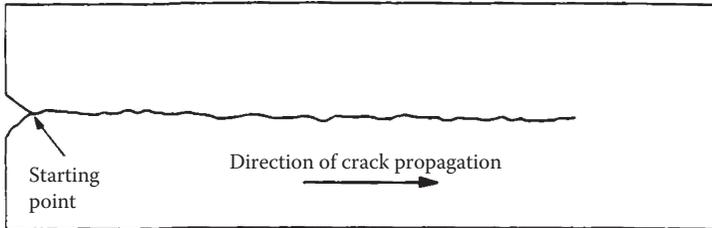
Figure 2.4 Chevron patterns in brittle fracture. (a) Chevron markings in steel. (From Rollason, E.C., *Metallurgy for Engineers*, 4th edn., Edward Arnold, London, U.K., 1977.) (b) Schematic representation.

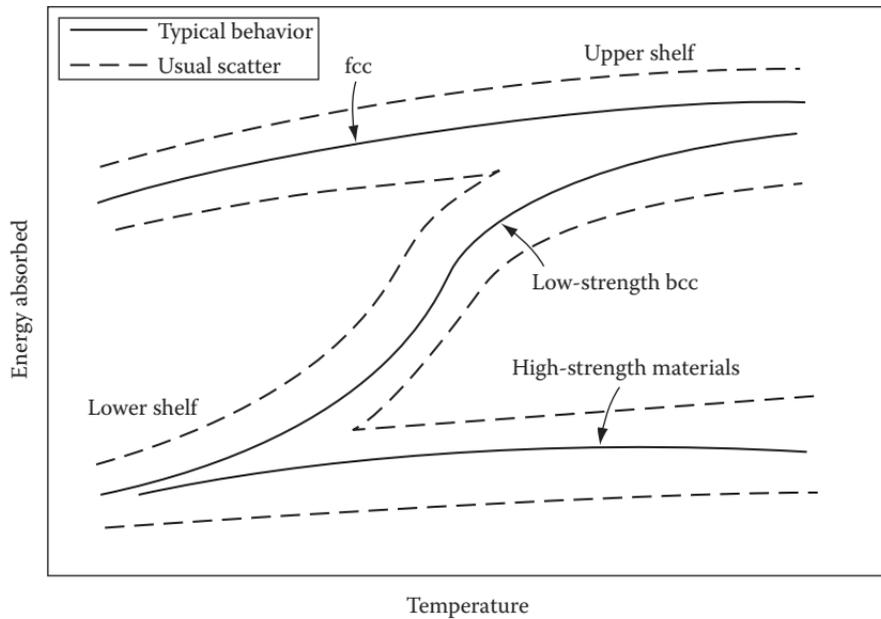
Figure 2.5 Schematic representation of the effect of temperature on the energy absorbed in fracture.

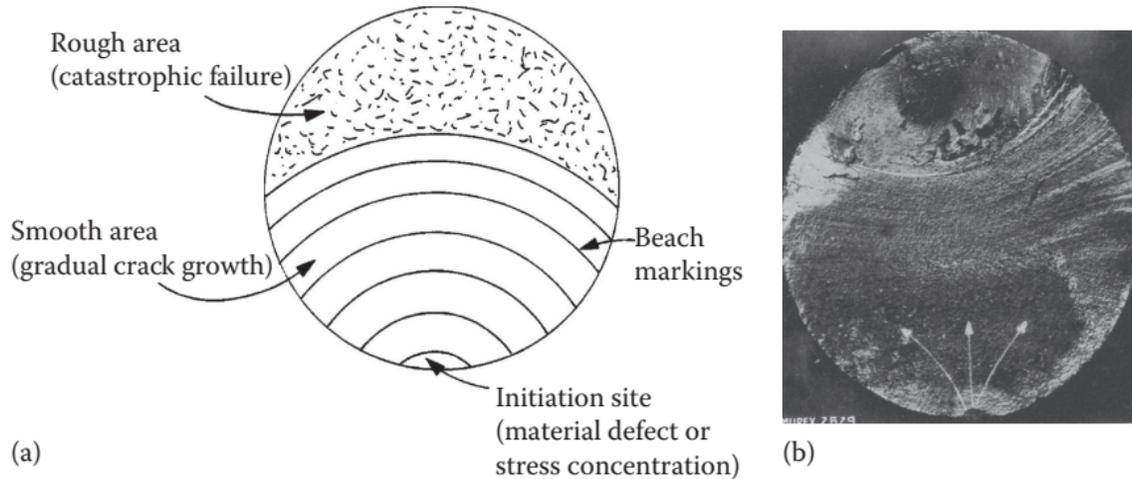
Figure 2.6 General appearance of a fatigue fracture surface. (a) Schematic representation; (b) fatigue fracture of automobile axle shaft. (From Rollason, E.C., *Metallurgy for Engineers*, 4th edn., Edward Arnold, London, U.K., 1977.)

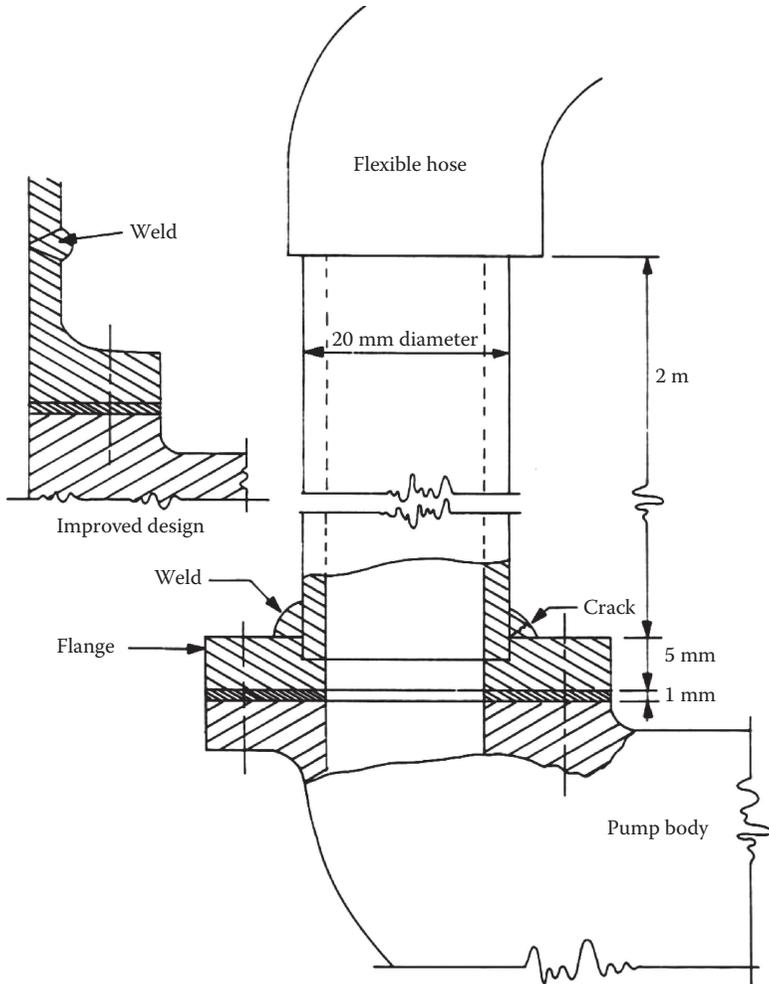
Figure 2.7 Failure of pressure line of a hydraulic pump.

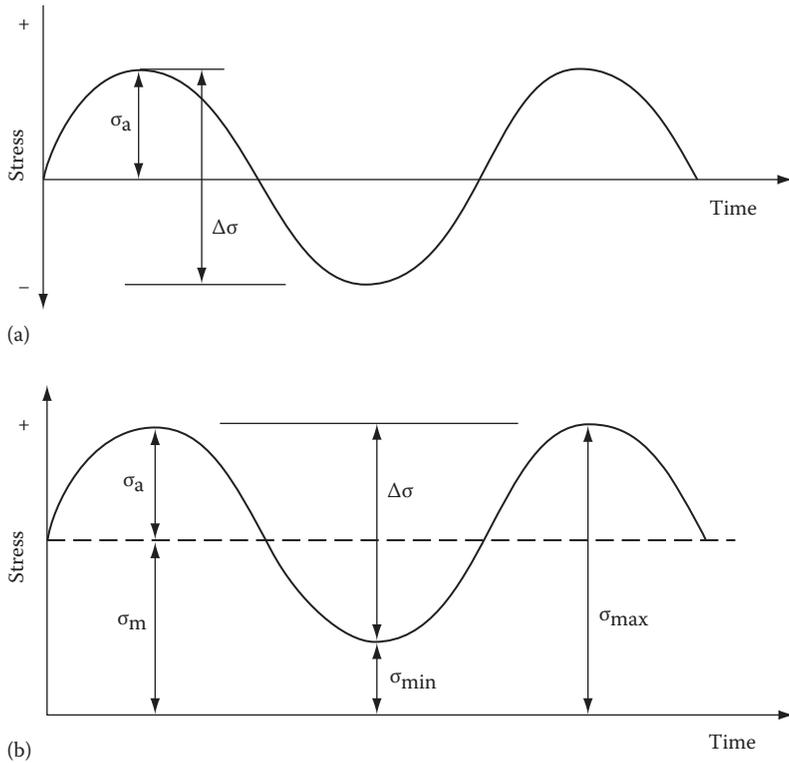
Figure 2.8 Types of fatigue loading. (a) Alternating stress, $R = -1$; (b) fluctuating stress.

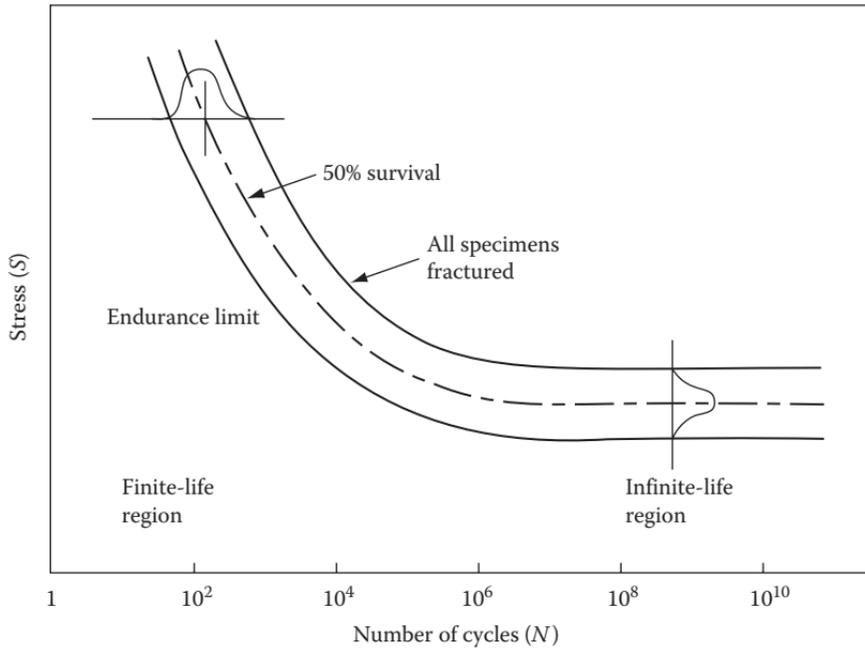
Figure 2.9 Representation of fatigue test results on the $S-N$ curve.

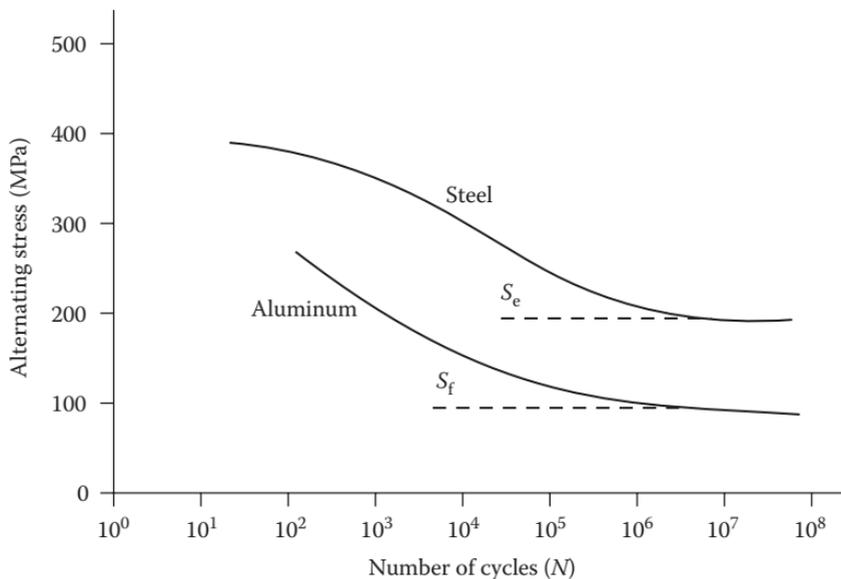
Figure 2.10 Fatigue results as represented by the S - N curves. Steel exhibits an endurance limit and its curve levels off at S_e . Aluminum does not exhibit an endurance limit, and its curve continues to decline for all values of N .

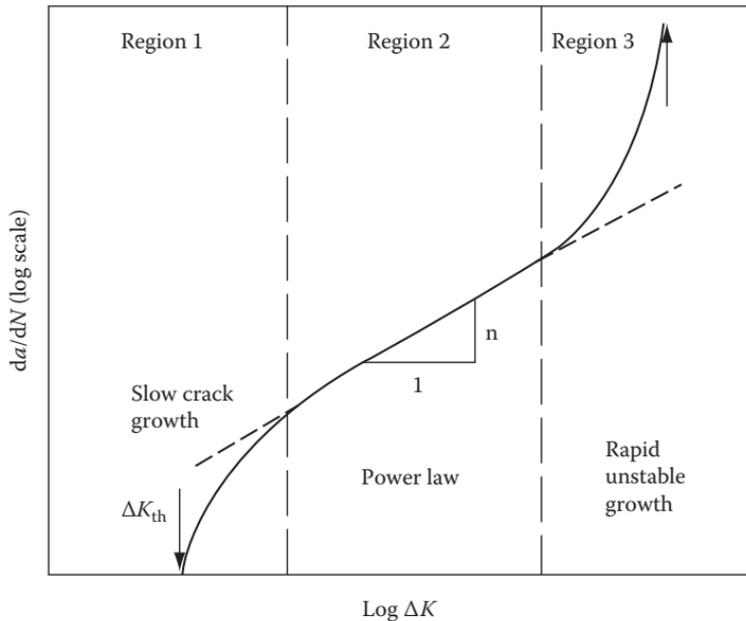
Figure 2.11 Schematic illustration of the effect of the range of the stress intensity factor (ΔK_I) on fatigue-crack growth rate (da/dN).

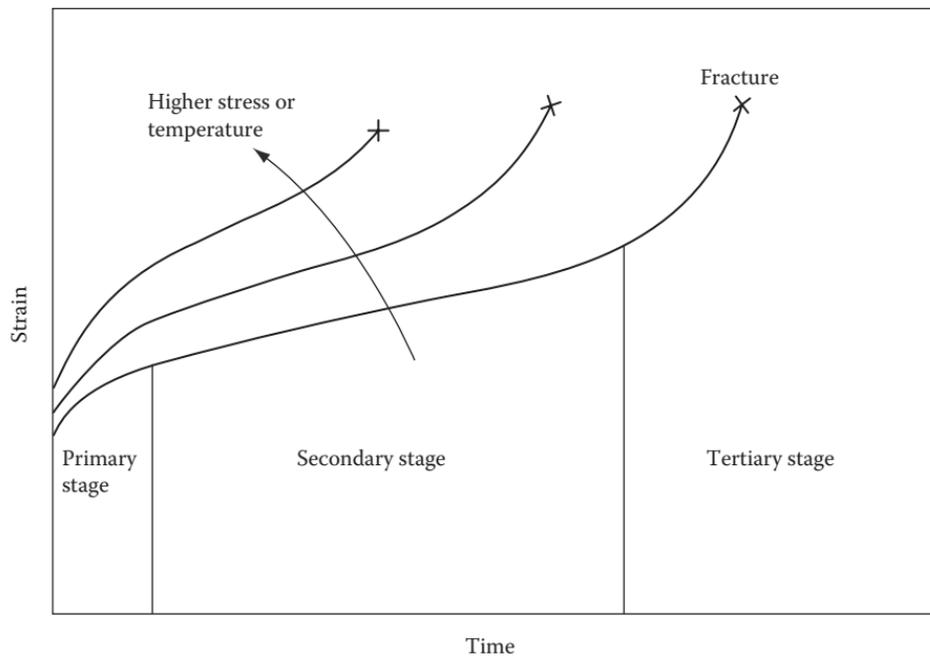
Figure 2.12 Schematic creep curve under tensile loading.

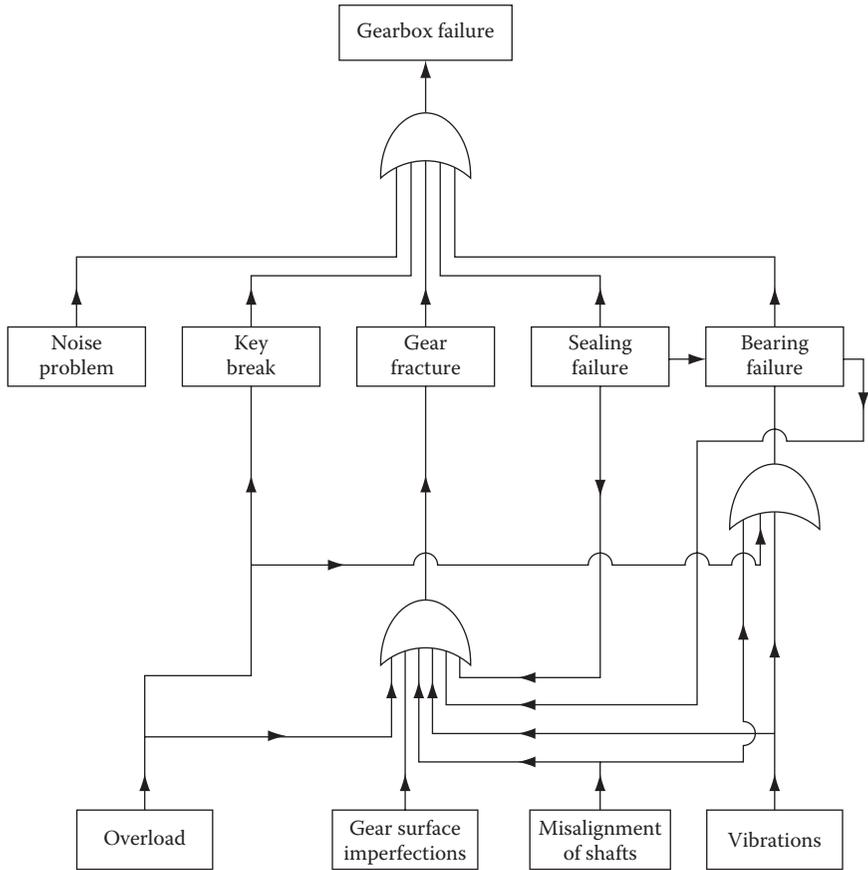
Figure 2.13 Simple analysis of a gearbox failure.

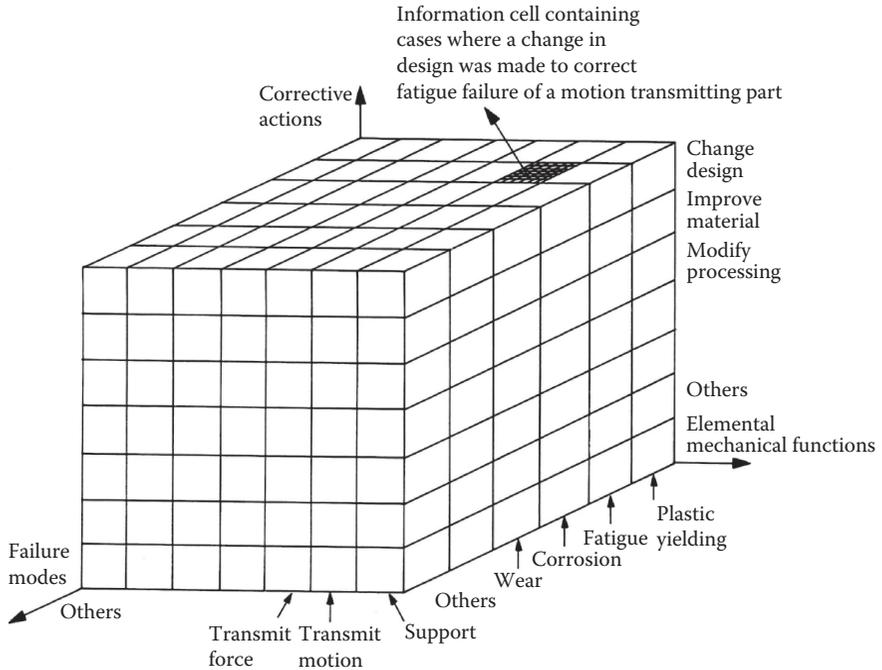
Figure 2.15 Part of failure experience matrix, which can be used to store failure information.
